March 12, 2021

Sundance Hills Metropolitan District
Park and Pool Facility Assessment Report
Revision 1

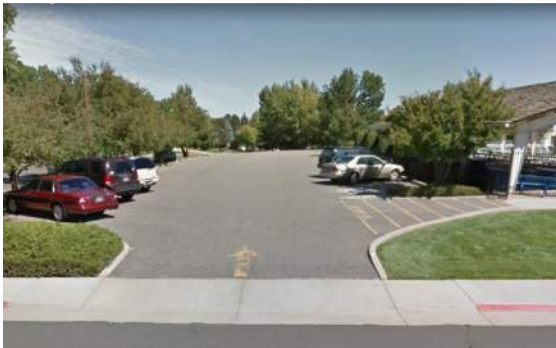
Parking Lot Entrance

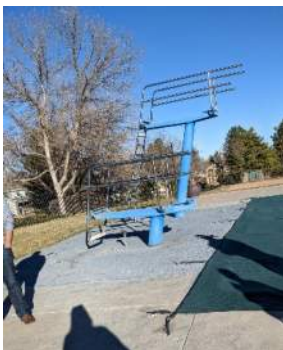
7. A few areas of the pool coping and skimmer tops are cracking, but appear in good condition in most locations.
8. The existing open-air shade structure on the north west corner of the pool deck appears to be in good shape. A new coat of paint is needed throughout the structure, especially on the wood components. The existing light fixtures in the shade structure are in poor condition and are mismatched. There is existing exposed conduit which should allow for ease in light fixture replacements.

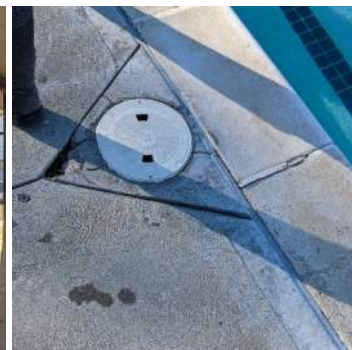
Drainage at North East Corner

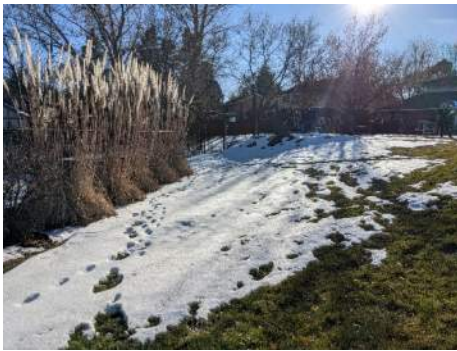
Drainage between Tennis and Pool

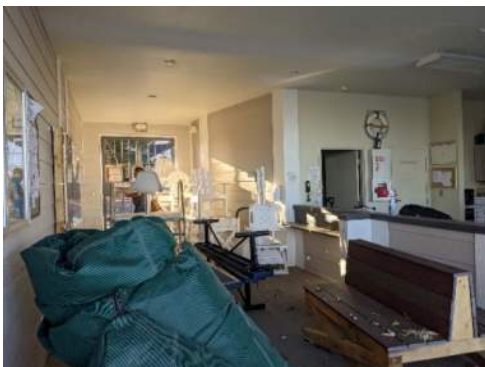
Breezeway Hall at Check-In

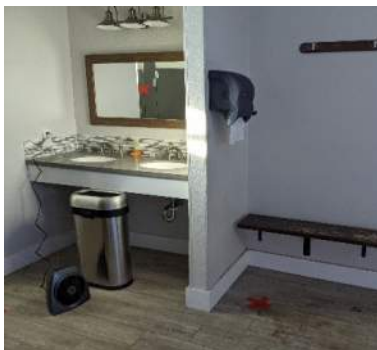
3. None of the toilets, showers, or sinks meet current ADA standards.
4. It was noted that a previous pipe leak may have caused some soil erosion issues below the slab edge at the west side, running between the men's toilet and women's showers. It created a void below the slab about 1'-6" deep, extending about 3' off the edge of the wall into the restroom area. This means the slab is cantilevering over a void space and could cause settling and slab breakage issues in the area. Cutting out the slab and providing proper compacted fill below should be explored.

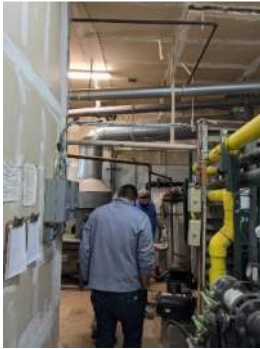
5. Pool chemicals are being stored in the pool equipment room. To preserve the life of the pool equipment and prevent addition corrosion, chemical storage should be in a separate, fire rated room to meet current code standards.

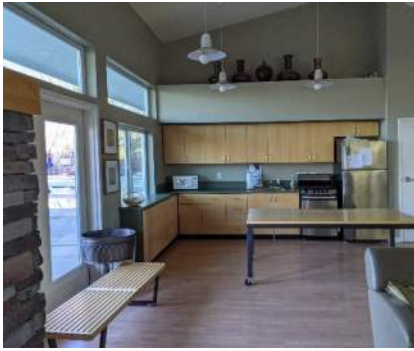
Kitchen in Community Room

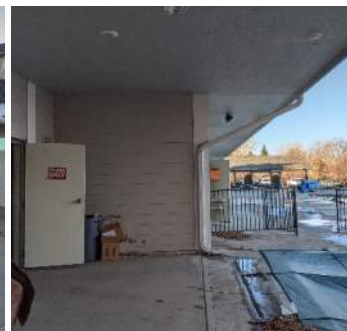
South East Corner Overhang

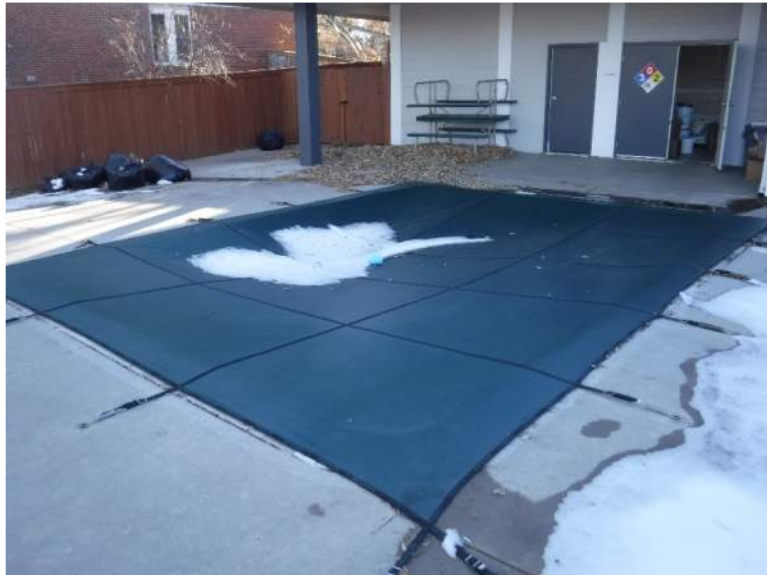
All three (3) of the pools utilize a skimmer perimeter overflow system, pre-cast coping stones, and a plaster finish. Underwater lights are in place at the lap pool. All three (3) pools utilize high rate sand filtration, natural gas fired heating, plastic commercial pool pumps, and TriChlor erosion feeder systems.

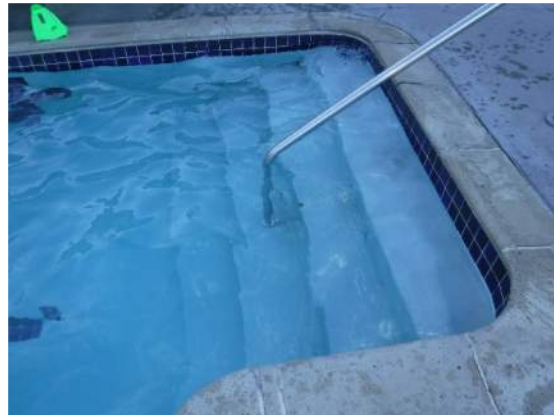
2. All pool plaster is in poor condition and is approaching the end of its useful life. C-H recommends resurfacing all three bodies of water with a proprietary quartz aggregate cementitious finish (Diamond Brite).

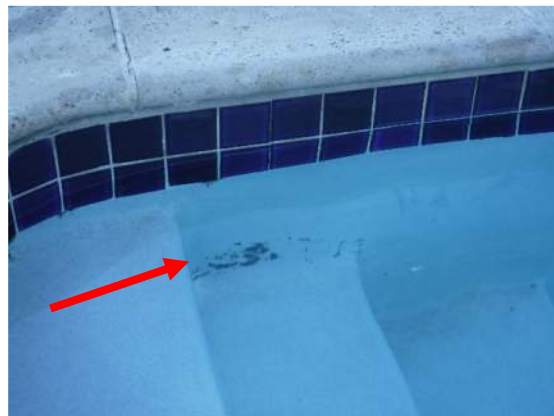
3. In several locations, the precast coping stone and caulking at the expansion joint shows signs of aging, cracking, and damage. Select stones and caulking around the Lap Pool are in need of replacement. Condition of stones and caulking could not be confirmed for the Diving Pool and Wading Pool.

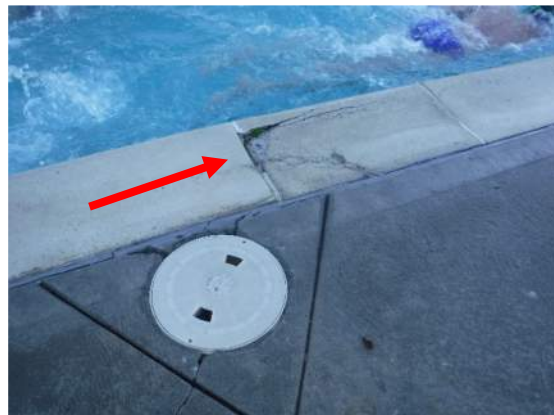
4. According to staff, several underwater lights are not working within the Lap Pool. C-H recommends replacement all of the wiring and niches with White LED Underwater Lights.

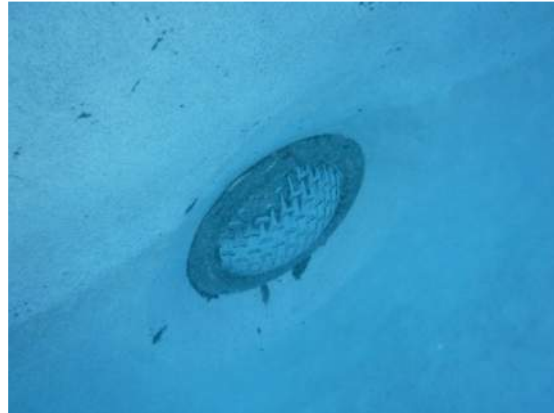
5. Staff mentioned that the Lap Pool has been repaired several times for leaks, and water is currently being lost from the pool at an approximate rate of $\frac{1}{4}$ " per day. While about $\frac{1}{8}$ " is accounted for with splashout and evaporation, C-H recommends pressure testing all piping to ensure leaks are not present beneath the pool deck, and performing a water tightness test on all pool structures during the re-plastering process.

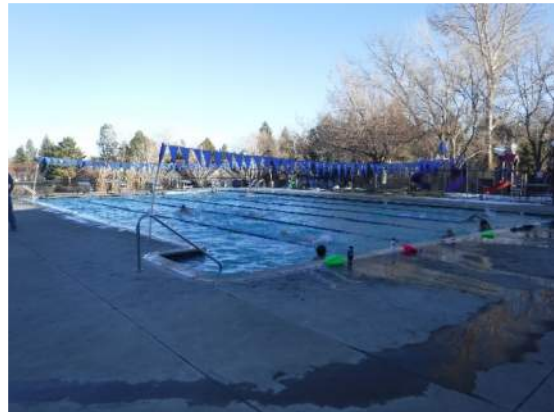
6. Six (6) starting blocks are provided at the Lap Pool. The platforms show signs of aging and delamination. C-H recommends resurfacing starting blocks to renew non-slip material. It is important to note that the Lap Pool maximum depth of 5ft meets USASwimming starting platform requirements for competition and experienced swimmers, but not for teaching racing starts.

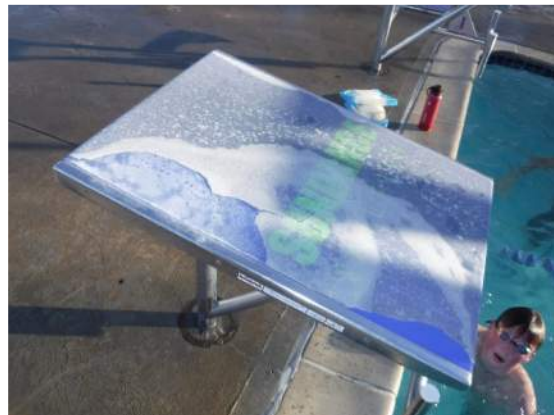
7. Various deck equipment is in fair condition and is beginning to show signs of aging. C-H recommends replacing backstroke stanchions, lane ropes, pool covers, cover reels, and safety covers for use during winterization.

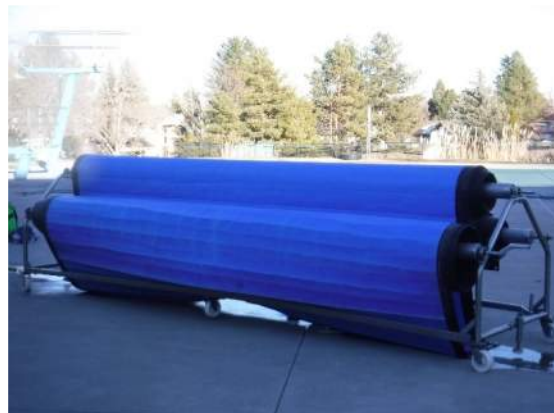
8. A portable ADA lift was observed, but it was not anchored pool-side as required by ADA. C-H recommends providing ADA access for all three (3) pools: permanent installation for existing lift at the Lap Pool, new ADA lift installation at the Diving Pool, and include a zero-depth entry at the Wading Pool replacement. Lifts cannot be moved from pool-to-pool, as this requires staff assistance for disabled patrons.

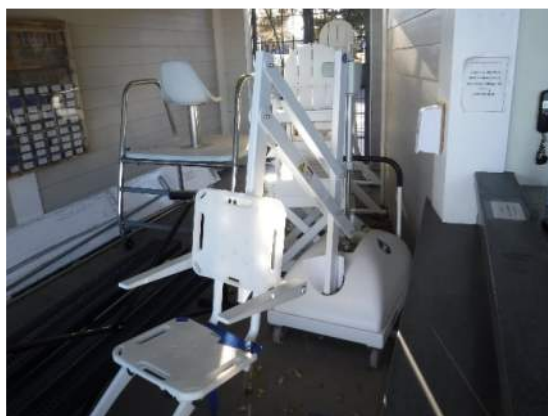
9. Based on website pictures, one (1) drain is provided at the Wading Pool. A minimum of two (2) drains must be provided in each pool to meet VGB compliance and state code. C-H recommends installing an additional main drain sump and grate. Additionally, VGB requires all main drain grates to be replaced every ten (10) years. C-H recommends replacement of all main drain grates at all pools.

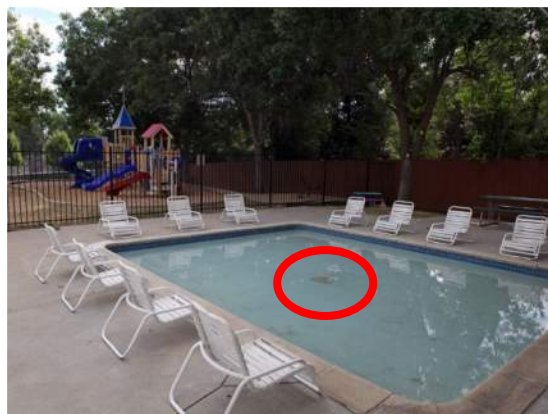
10. The wading pool is outdated and does not meet modern aquatic industry standards. C-H recommends a replacement of the existing wading pool with a larger, zero-depth entry wading pool with ground sprays, interactive spray features, a toddler slide, a play structure, or a combination of these items.

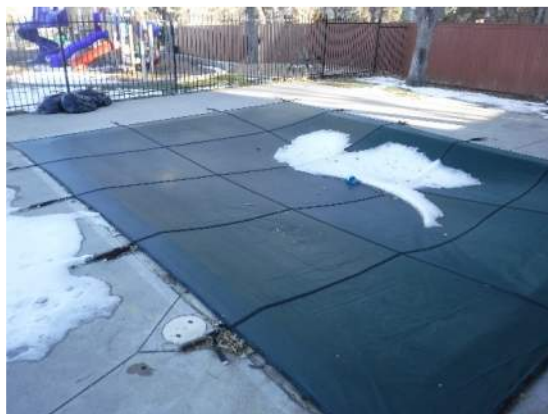
11. The diving board locations were measured while on-site. Both springboards are within 10ft of the side walls of the diving pool, which violates code. The dive stand guard rails do not protrude past the pool wall, which creates a safety hazard. C-H recommends re-installing dive stands to provide adequate dimensions to side walls. C-H also recommends replacement of dive stand guard rails.

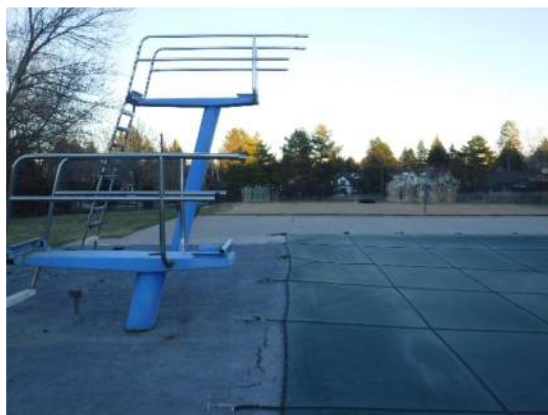
12. The diving pool envelope could not be measured on-site due to the safety cover installation. The pool's maximum depth could not be confirmed while on-site. The envelope must comply with the minimum dimensions shown in section 3.1 of Colorado Pool Code – staff to confirm. If dimensions are not met, Diving Pool modification is recommended. Refer to Appendix C for discussion of options.

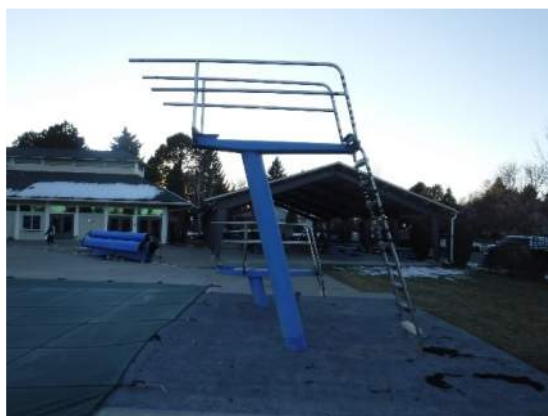
13. The safety padding located underneath the diving boards is deteriorating and requires repair (short term) or replacement (long term). C-H recommends installing watertight foam protection - SoftSide by RenoSys at diving board locations.

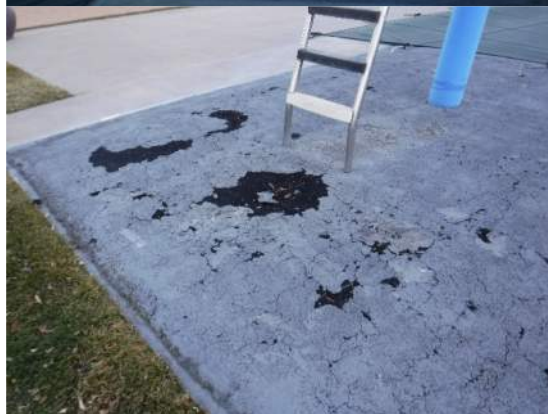
14. TriChlor is currently added to the pools using Pentair gravity erosion feeders. pH buffer feed systems and water chemistry controllers are not present per aquatic industry standards. C-H recommends providing dedicated chemical storage rooms and installing the following for each pool system: automated calcium hypochlorite erosion feeder, automated pH buffer chemical feed system, and a dedicated water chemistry controller.

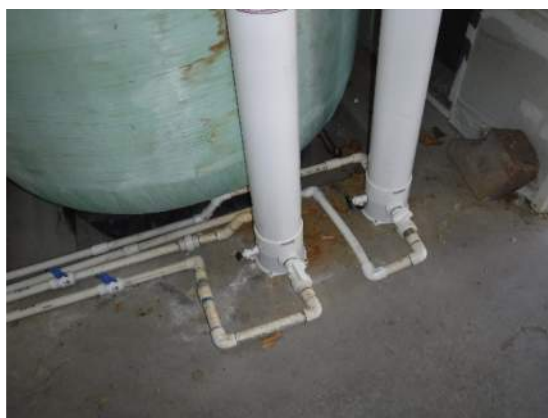
15. Exposed pool piping within the mechanical room is made of several different materials. Select runs of piping are not properly supported. Cross-connections were observed between pools, which goes against modern aquatic industry standards. C-H recommends replacement of all exposed pool piping to Schedule 80 PVC that is properly supported in all locations and is labeled/colored per code.

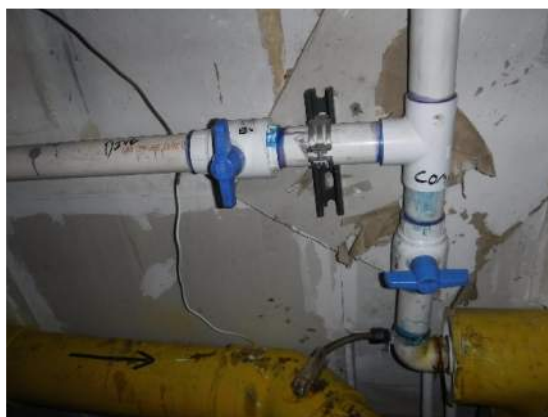
16. Recirculation pumps for the Lap and Dive Pools are Pentair Commercial Plastic Pumps. Staff indicated that these pumps are roughly six (6) years old. Staff mentioned that pumps shake during operation. This is due to the pumps being located above water level. C-H recommends replacing the recirculation pumps in kind, but providing a pump pit, VFDs, gauges, and concrete housekeeping pads for proper operation.

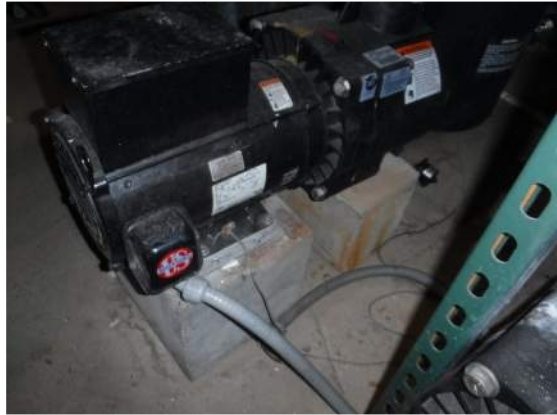
17. Vertical high rate sand filtration tanks are provided at the Lap and Dive Pools. The filter tanks and piping show signs of aging. Schedule 40 PVC face piping is provided which does not meet industry standard. Gauges are missing from the face piping. C-H recommends providing horizontal high rate sand filtration tanks with Schedule 80 PVC face piping, backwash valves with mechanical linkages, and influent/effluent gauges.

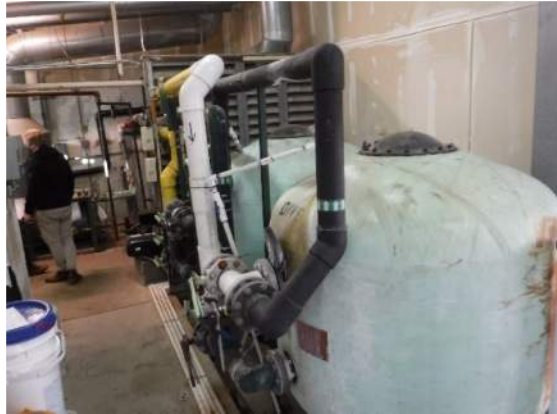
18. Two natural gas fired pool heaters are provided: one is by Laars (~20 years old) and the other is by Raypak (~12 years old). Heaters are in working order, but show their age and are reaching the end of their lifespans. C-H recommends like-kind heater replacements (manufacturer selection by Owner). Heaters should be provided with CPVC influent/effluent piping and shall be sized for pool use during shoulder seasons.

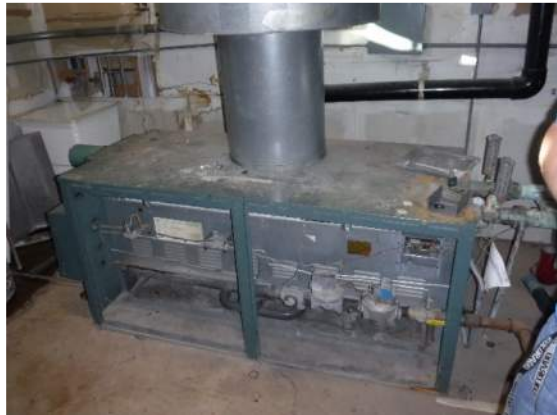
19. The existing Wading Pool equipment is included in the corner of the room. In order to meet all applicable codes and industry standards, C-H recommends providing new recirculation and heating equipment when the Wading Pool is replaced.

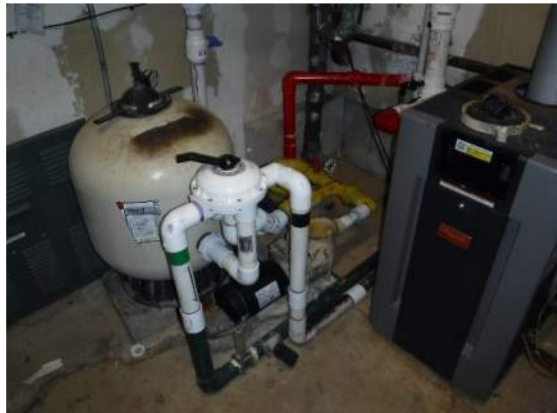
OPINION OF PROBABLE COST

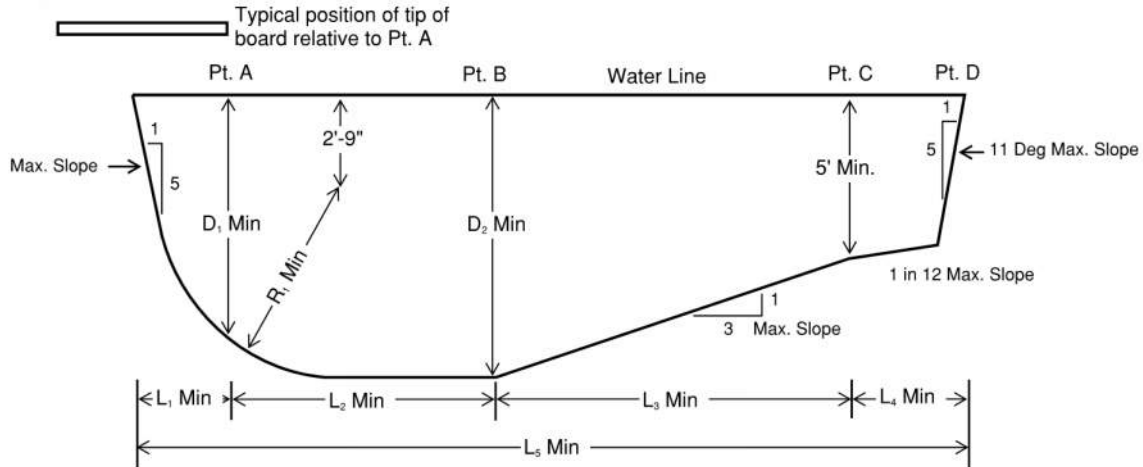
Note: L₄ is a minimum dimension to allow sufficient length opposite the board. This may of course be lengthened to form the shallow portion of the pool.

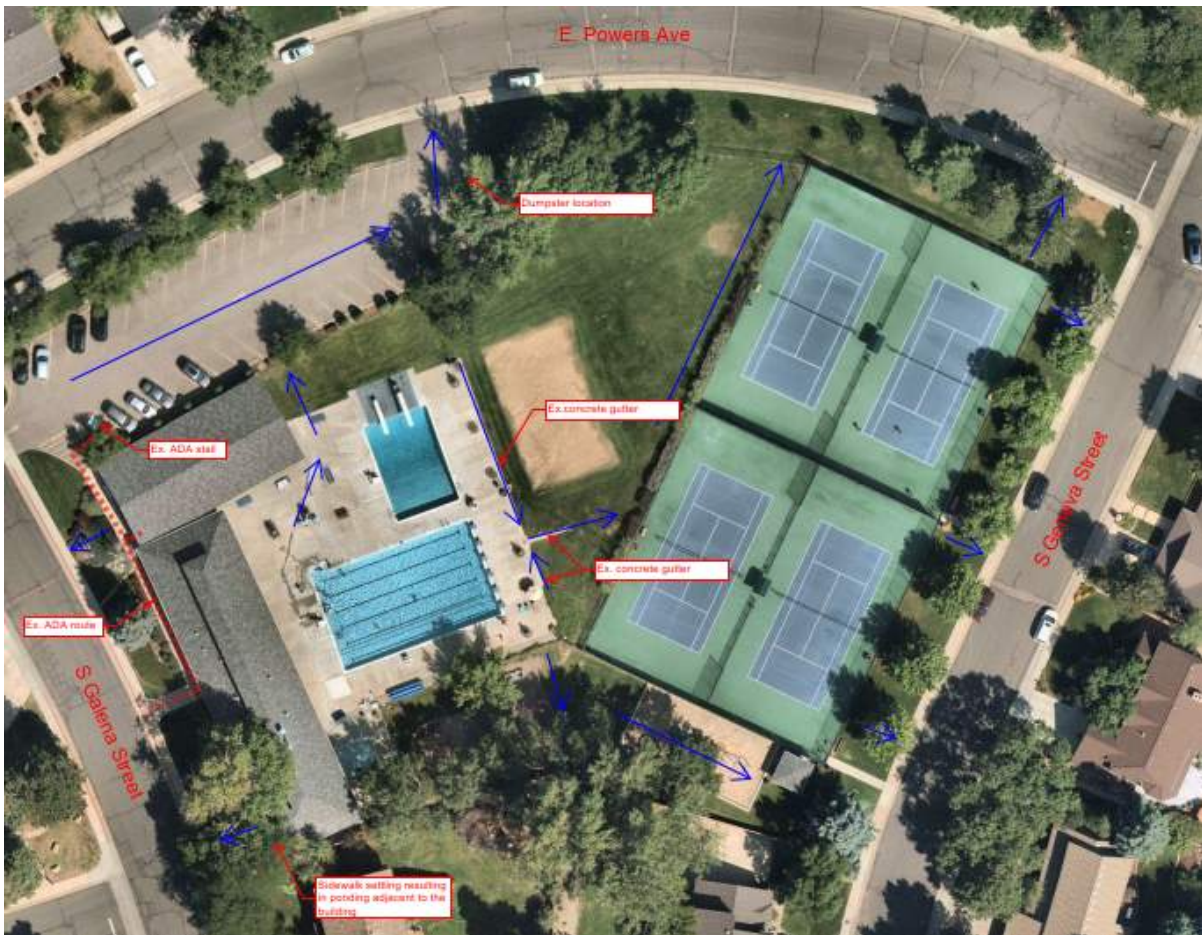
The lack of water quality and detention facilities does not meet current City design standards. Any increase in impervious area may trigger additional drainage requirements.

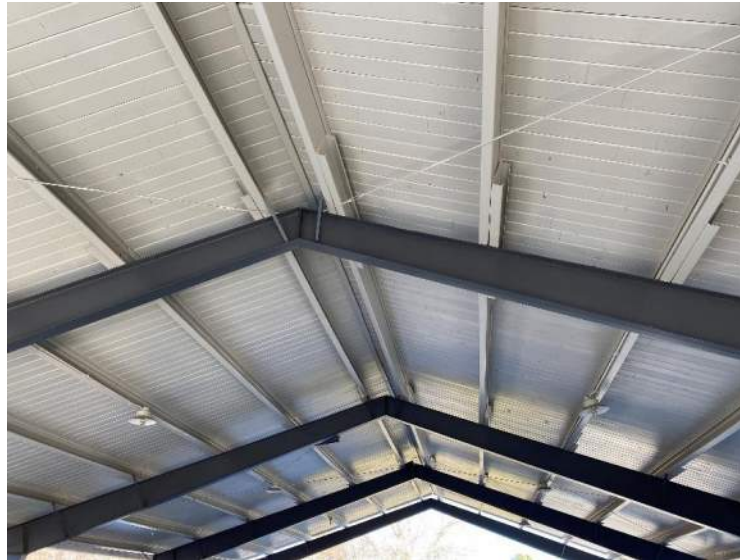
Photo 1: Pavilion Structure

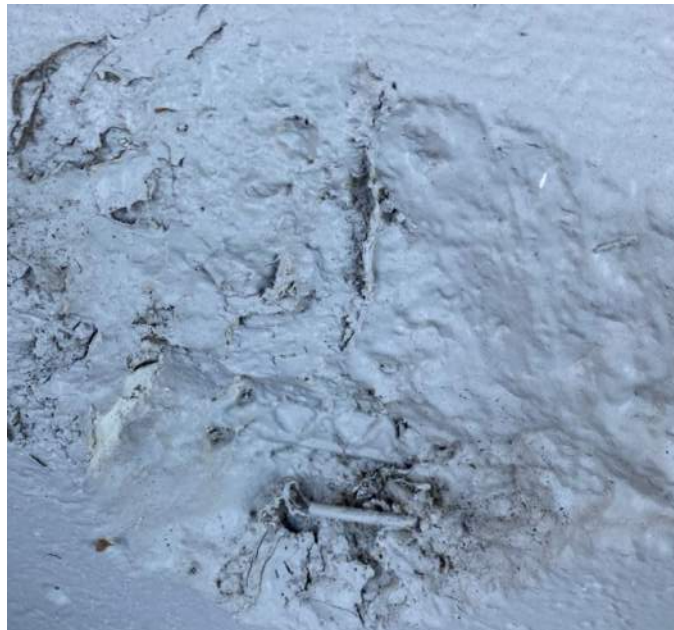
Photo 2: Exposed stem wall rebar

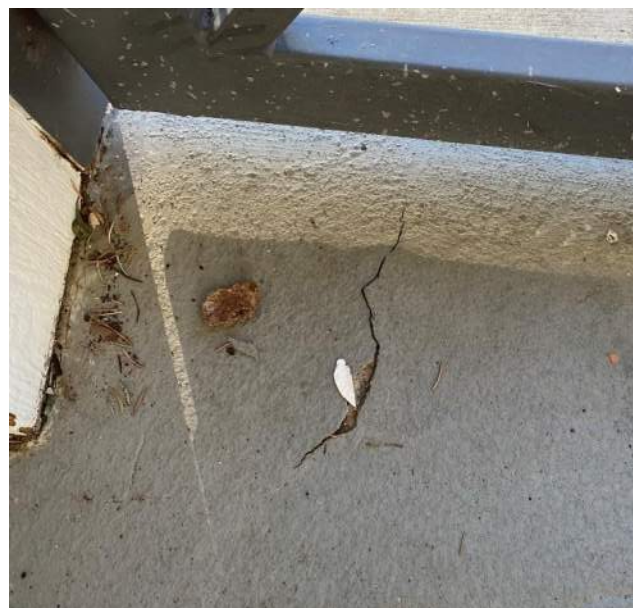
Photo 3: Cracking floor coating at central walkway

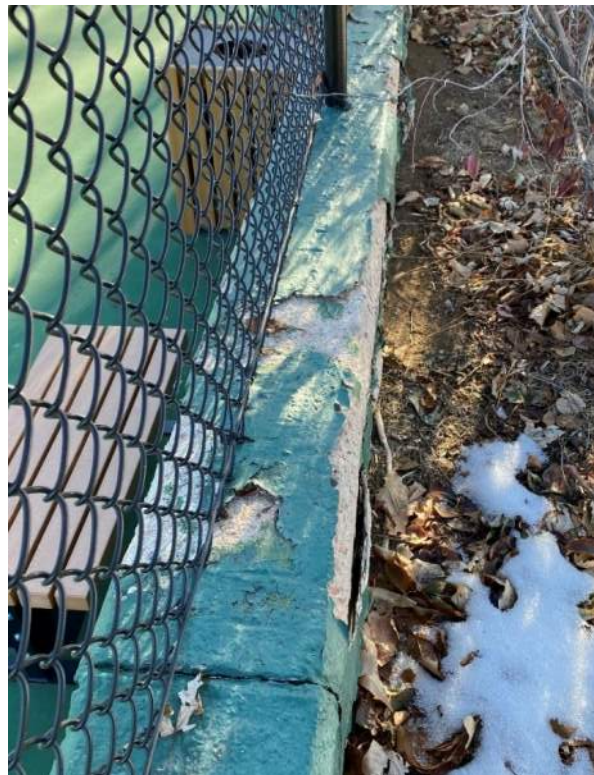
Photo 4: Coating failure at tennis court retaining walls

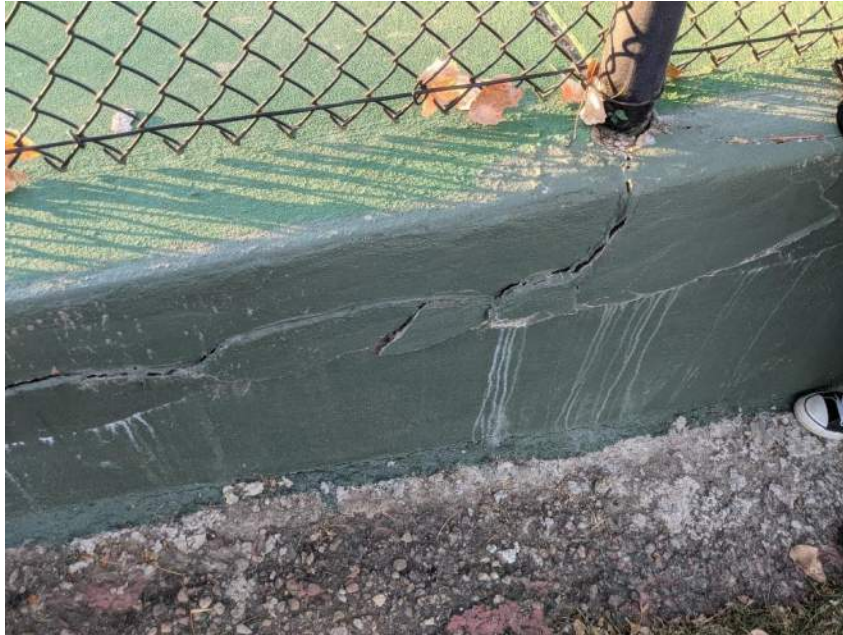
Photo 5: Spalling at east side of tennis courts

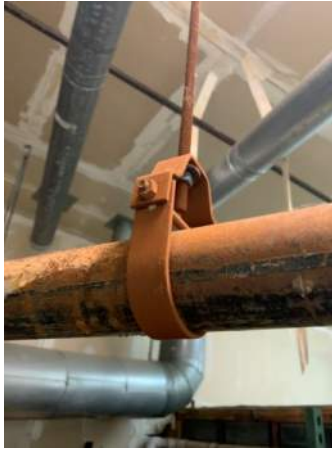
GAS PIPE AND HANGER CORROSION

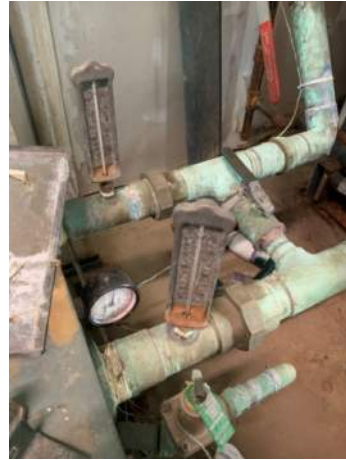
POOL BOILER PIPING CORROSION

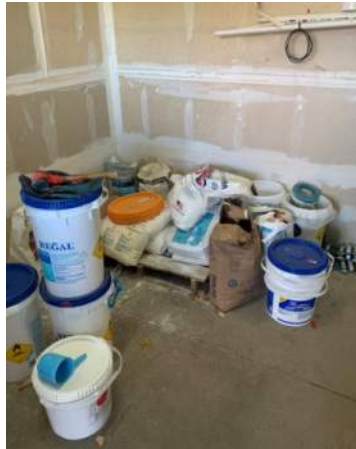
POOL CHEMICAL STORAGE AREA

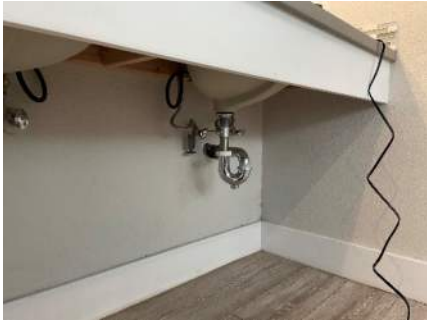
11. The gas fireplace is not working. It is unclear what has failed.
12. The drinking fountain is not leaking and it appears to be in good condition.
13. Currently, there is no emergency eyewash or shower in the pool equipment room.

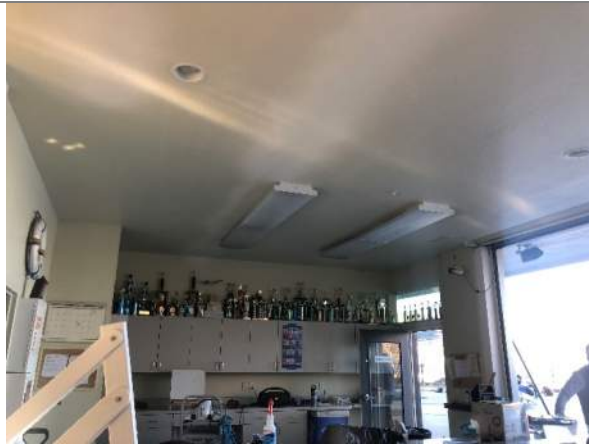
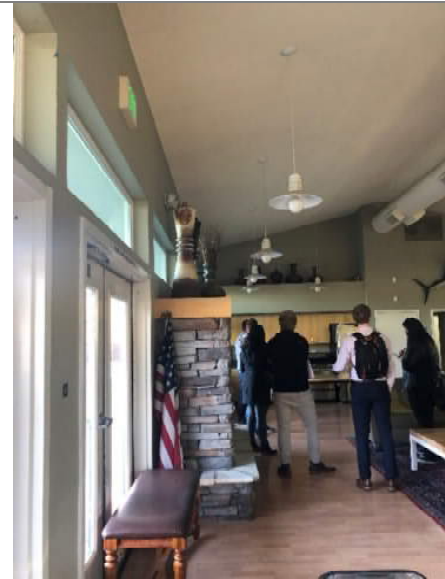
Existing Downlights, Damaged Exit Sign, Existing Emergency Lighting Unit

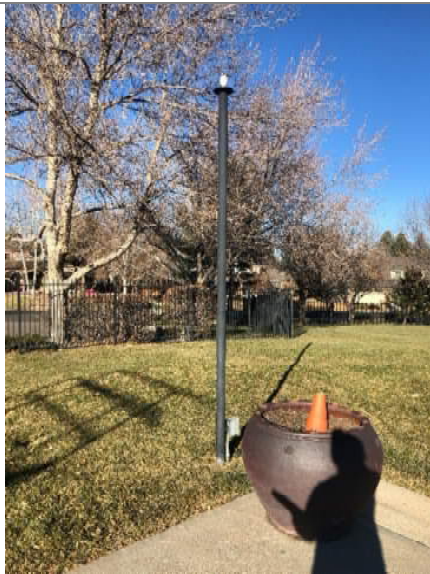
ROOM: Exterior - Pool Deck
Existing Post-Top Area Light - Globe Missing

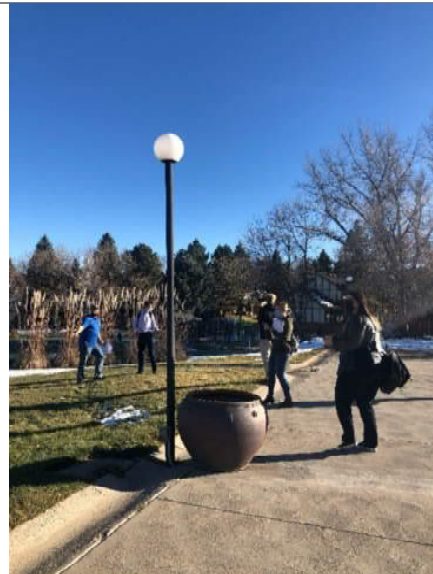
ROOM: Exterior - Pool Deck
Existing Post-Top Area Light with Globe
